DEPARTMENT OF TRANSPORTATION

Contract #: 04-0120F4Cty: SF/ALA Rte: 80 PM: 13.2/13.9File #: 69.28**WELDING INSPECTION REPORT****Resident Engineer:**Pursell, Gary**Address:** 333 Burma Road**City:** Oakland, CA 94607**Report No:** WIR-010163**Date Inspected:** 06-Nov-2009**Project Name:** SAS Superstructure**OSM Arrival Time:** 645**Prime Contractor:** American Bridge/Fluor Enterprises, a JV**OSM Departure Time:** 1900**Contractor:** Zhenhua Port Machinery Company, Ltd (ZPMC), Changxing Island **Location:** Shanghai, China**CWI Name:** Li yang**CWI Present:** Yes No**Inspected CWI report:** Yes No N/A**Rod Oven in Use:** Yes No N/A**Electrode to specification:** Yes No N/A**Weld Procedures Followed:** Yes No N/A**Qualified Welders:** Yes No N/A**Verified Joint Fit-up:** Yes No N/A**Approved Drawings:** Yes No N/A**Approved WPS:** Yes No N/A**Delayed / Cancelled:** Yes No N/A**Bridge No:** 34-0006**Component:** OBG Components**Summary of Items Observed:**

TRAIL ASSEMBLY YARD

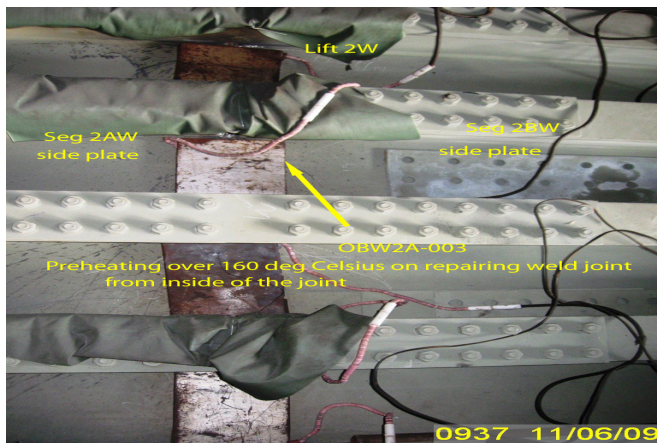
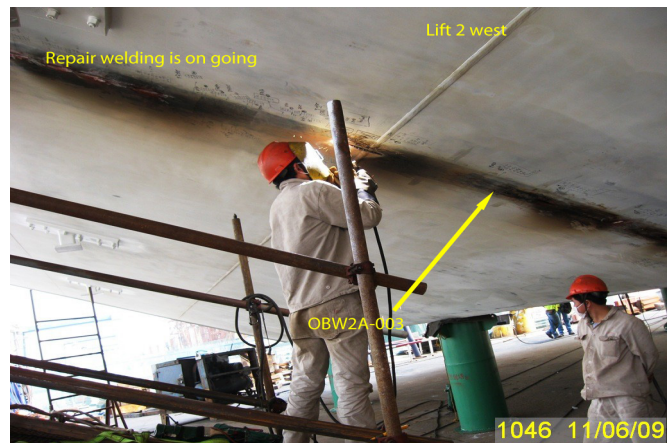
SMAW repair welding on weld joint 003 located at OBE2A side plate (external). Welder is identified as 049769. ZPMC QC is identified as Mr.Wu zhi cheng and CWI is identified as Mr.Li yang. The welding variables recorded by QC appeared to comply with WPS-345-SMAW-3G (3F)-FCM-Repair-1.ZPMC is using old CWR repair procedure for this repair #BCWR-859. This is informed to CT SMR Mr.Jim simonis.

Witnessed ongoing post weld heat treatment of repair weld joint 003 located at OBE2A side plate (external). The temperature and holding time recorded by QC appeared to comply with WPS-345-SMAW-3G (3F)-FCM-Repair-1.

ZPMC is making cope hole of radius 25mm and smooth finish at FL-1 and FL-2 of 5AW PP29, this is checked with ZPMC QC Mr.Zhang qiang.
